OPERA DELLA PRIMAZIALE PISANA

THE BAPTISTRY

**TECHNICAL DESCRIPTION AND
IDENTIFICATION OF EXISTING STAINED
GLASS WINDOWS AT PRESENT UNDER
RESTORATION**

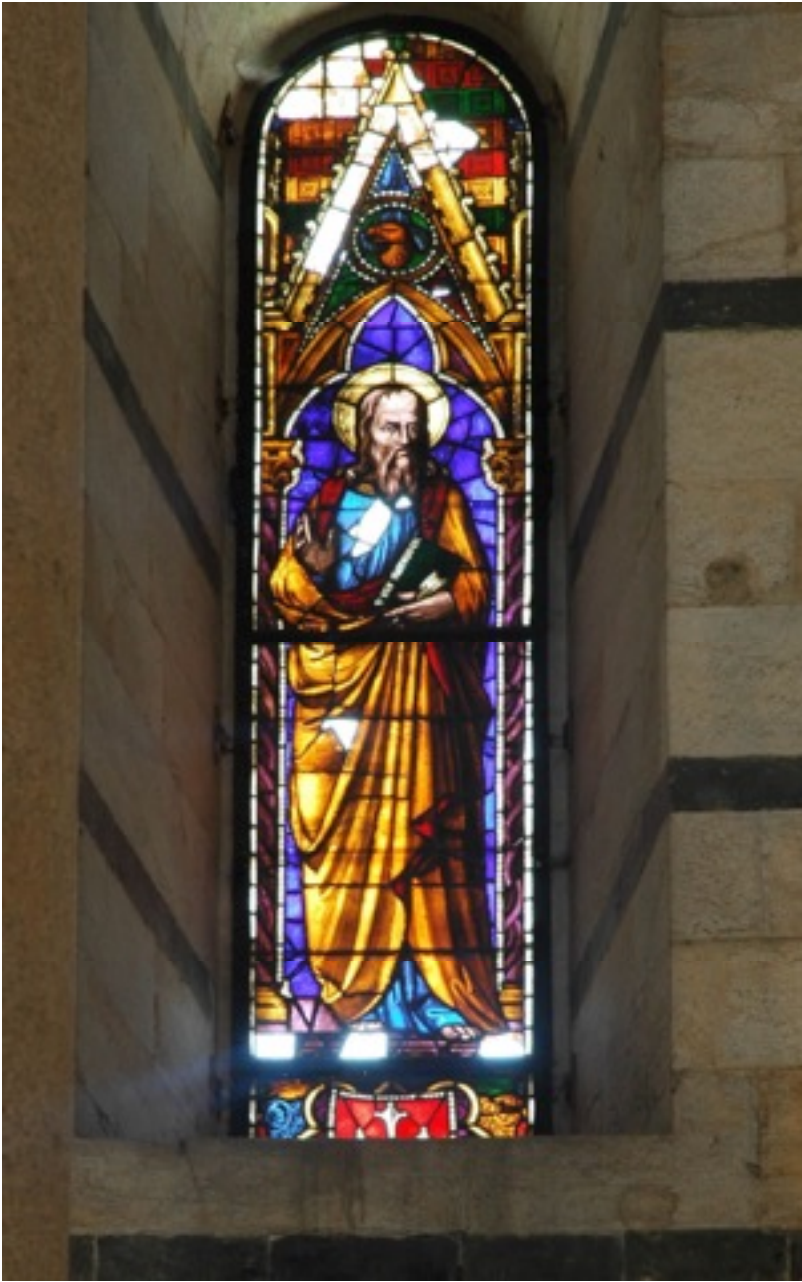
RIF.: 1pt on page 'P

Tesserae to be replaced in gaps to complete the design. Areas involved. Areas in need of repair: of modest dimensions.

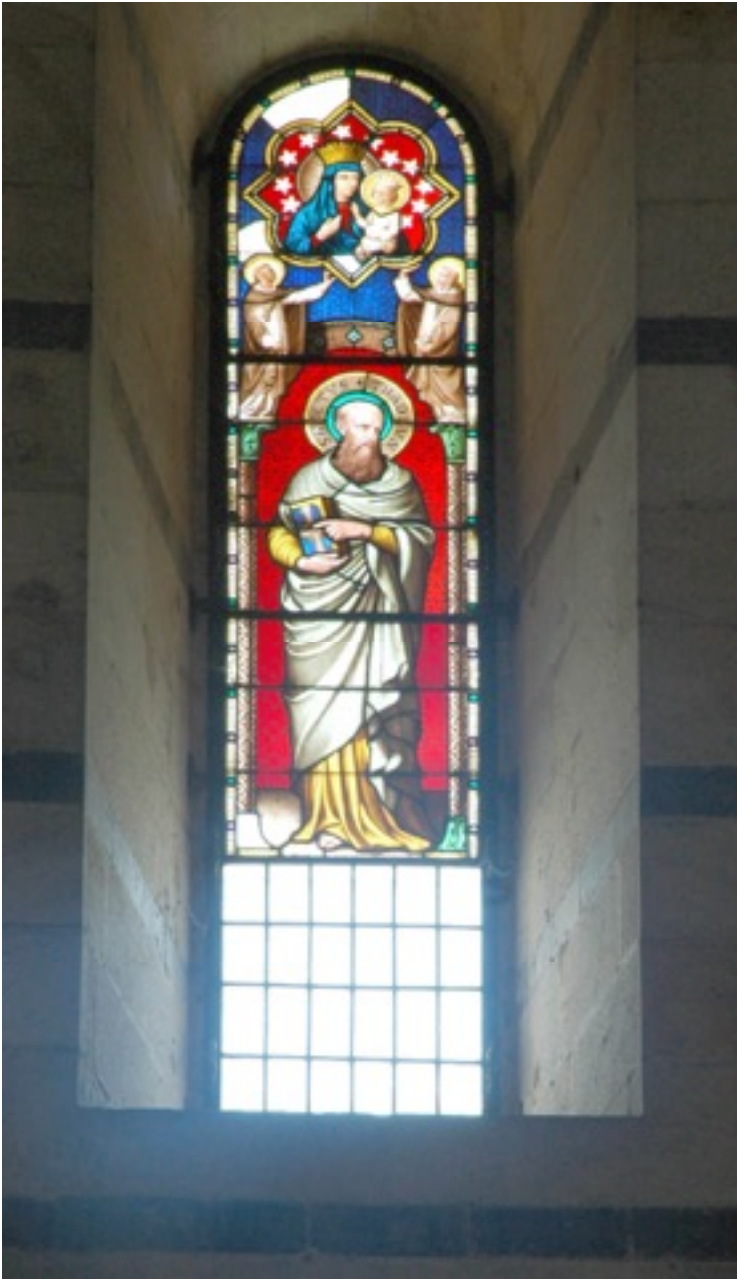
RIF.: **2pt** on page 'abaco delle vetrate'

SUMMARY OF WORK TO BE DONE Gaps to be filled to complete the design of the window. Small areas missing in the upper register, extensive in the lower with no residual trace of the original design. Requires completely new work for integration.

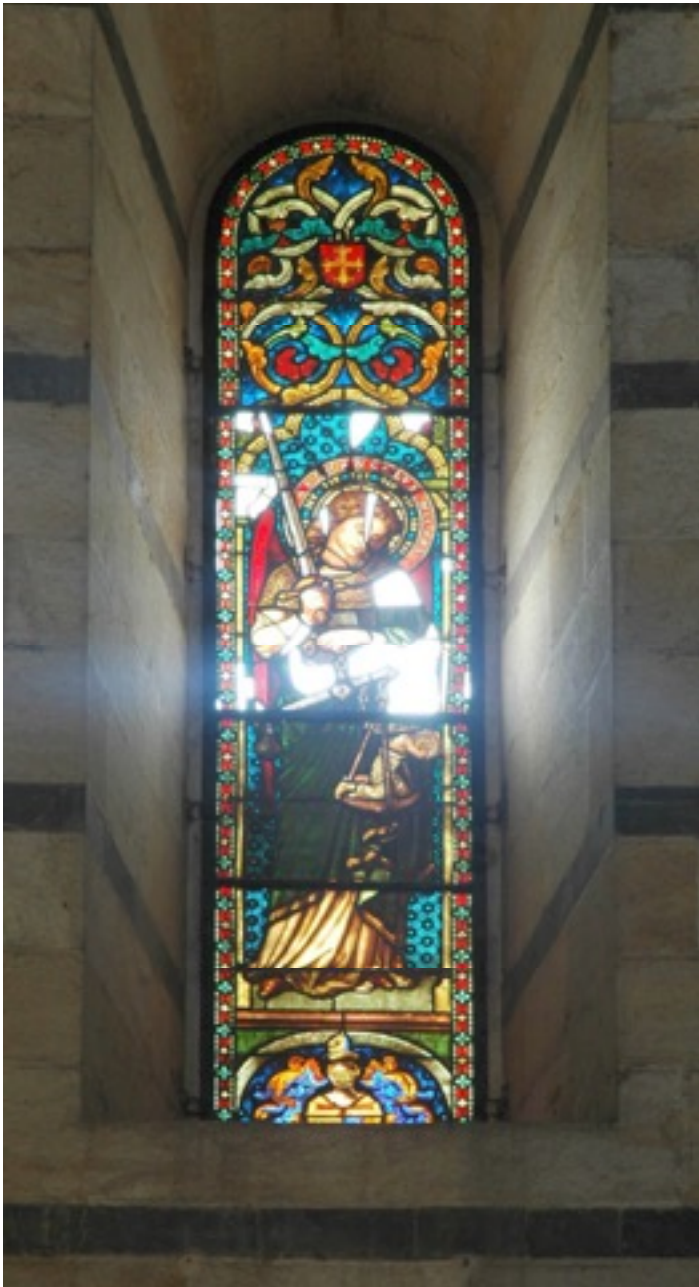
Ditta Fratelli Bertini (Giuseppe e Pompeo) - MILANO
Arcangelo Michele
1850-1865

Several parts missing from the design.

Areas involved: small but in important parts of the figure

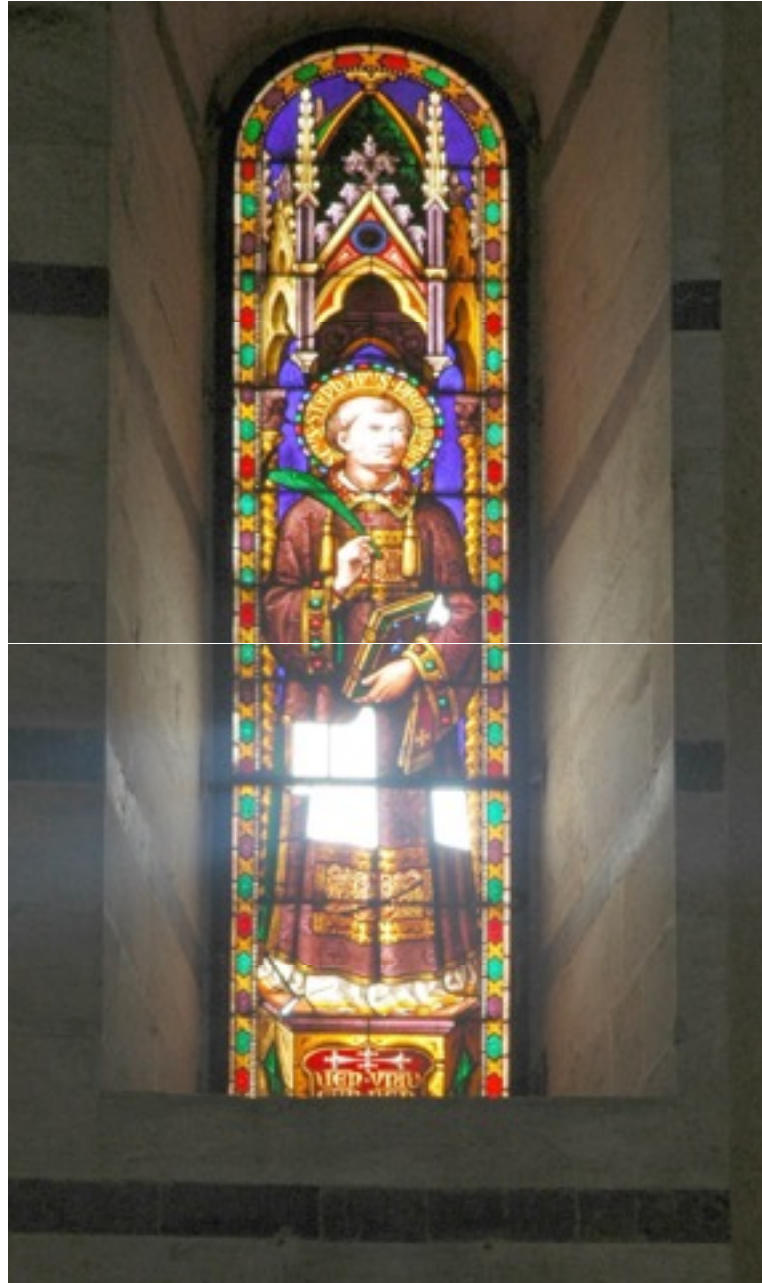
REF.: 4pt on page 'abaco delle vetrate'

SUMMARY OF INTERVENTIONS Missing pieces to be replaced to complete the design. Size of areas involved: small

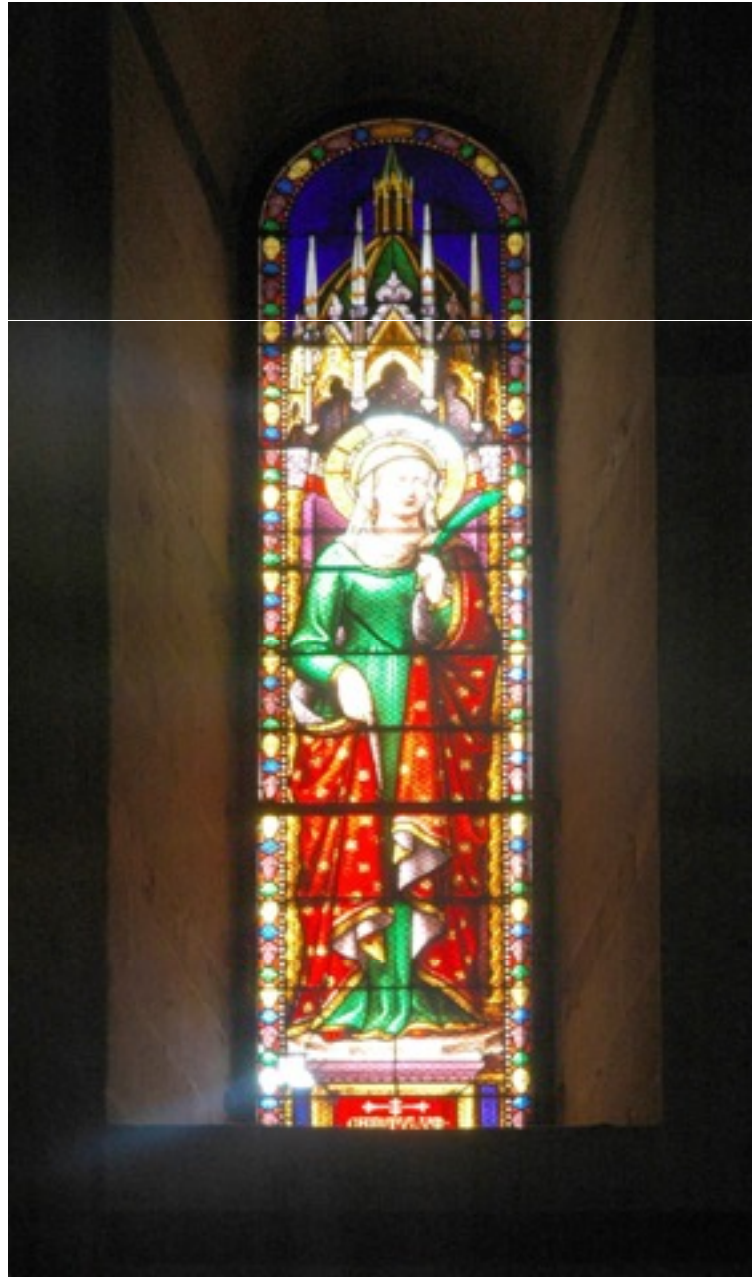
Guglielmo Botti
Santa Reparata? 1855-1865
5th plate in Abaco delle vetrate

SUMMARY OF INTERVENTIONS Missing pieces to be replaced to complete the design.
Size of area involved: Small

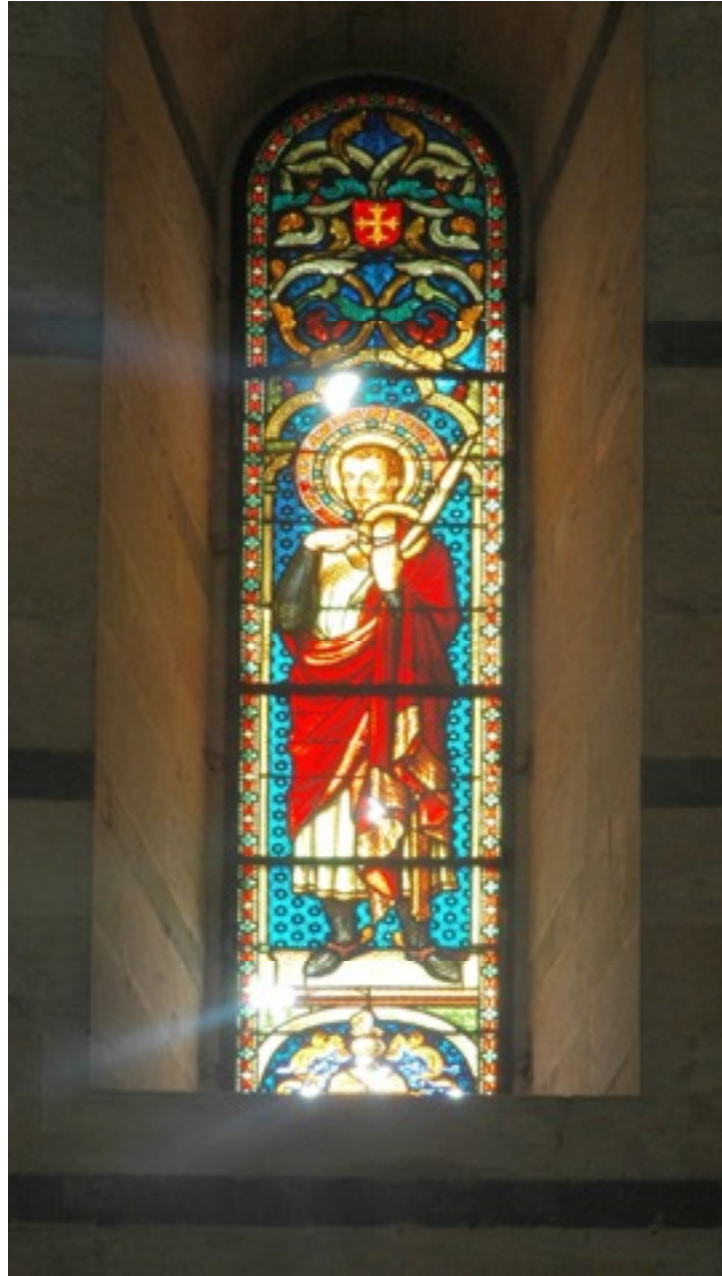
6th place in 'abaco delle vetrate'

Missing pieces to be replaced to complete the design Size of area involved: Small
7th place 'Plan of the Windows'

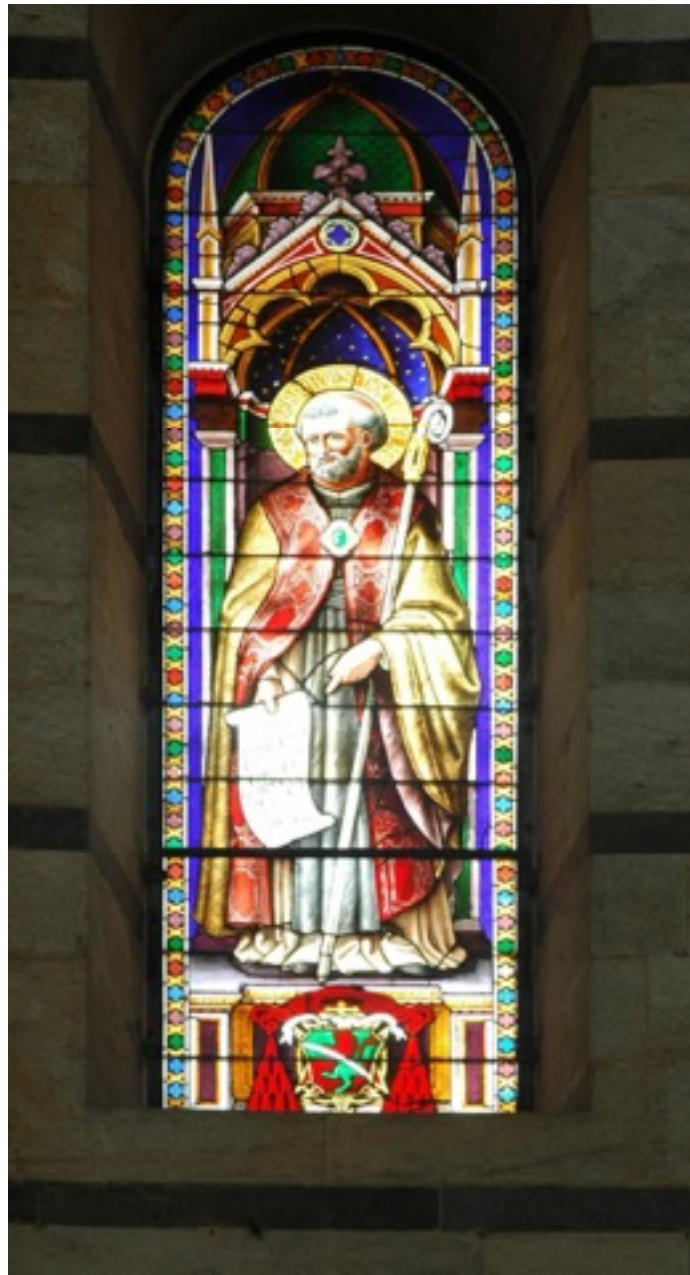
Summary of work to be done: Widow almost complete. State of leading and grisaille to be carefully checked.

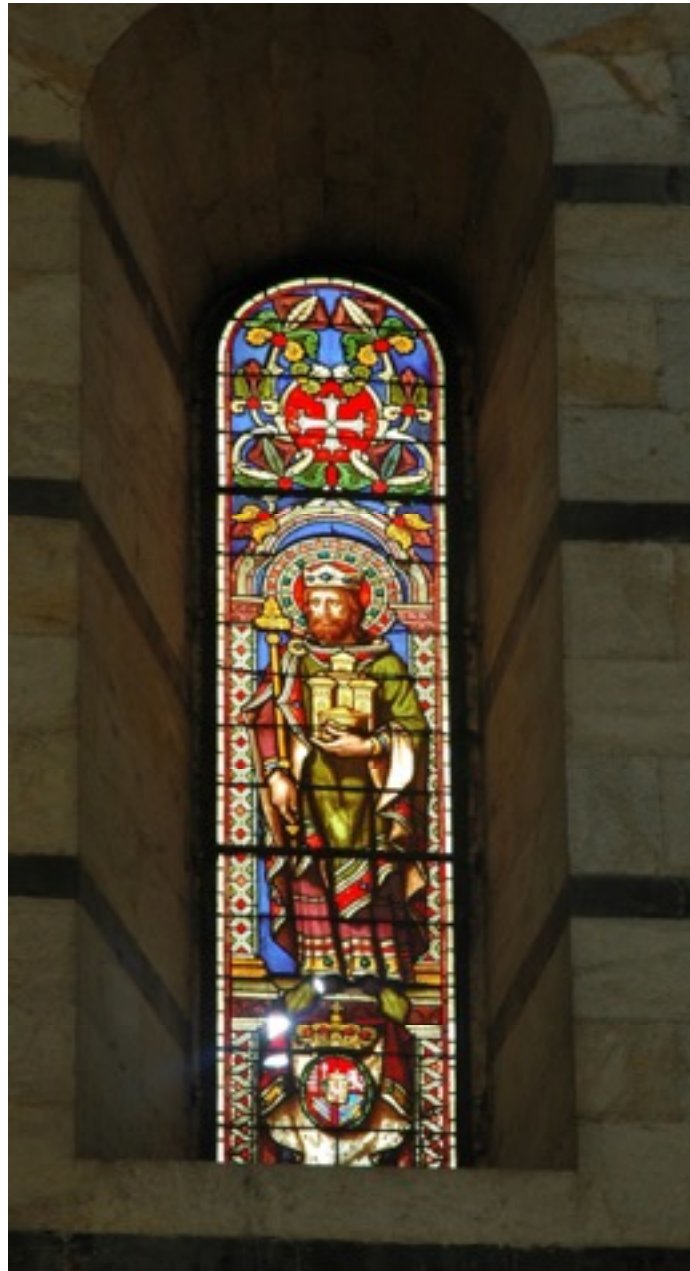
RIF.: **11th** in the list of windows in 'plan of the windows'

Very few pieces missing: the state of repair of leading and grisaille to be carefully checked.

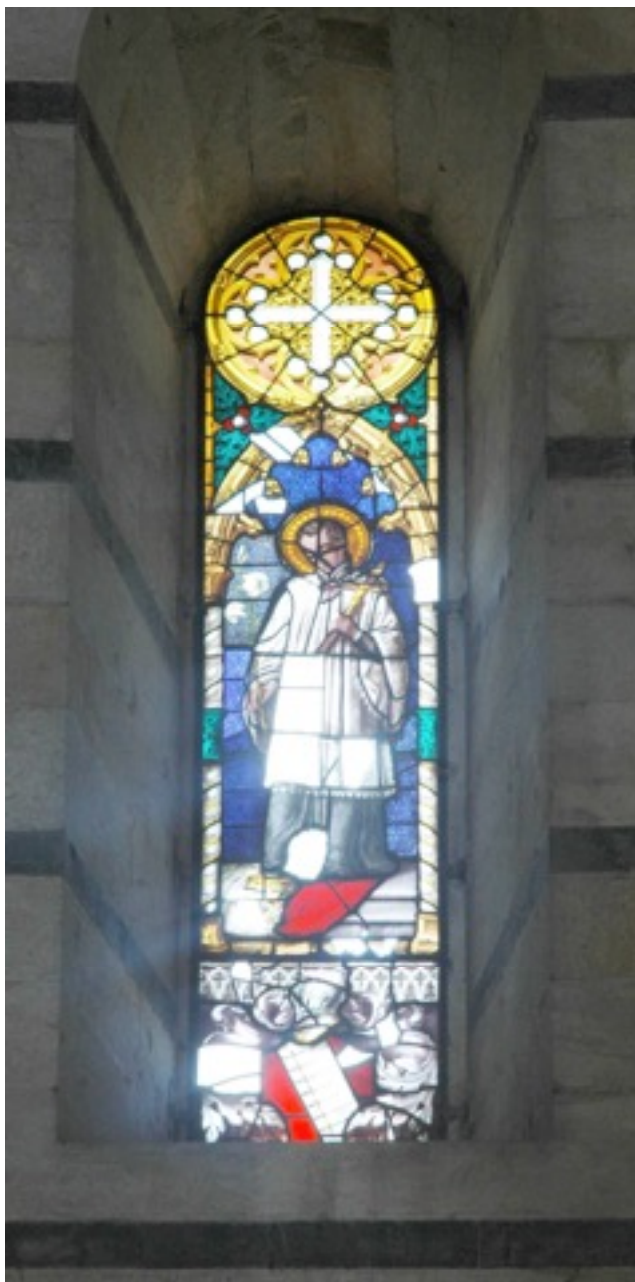
RIF.: 13pt in list 'abaco delle vetrate'

Very little damage: condition of the leading and grisaille to be carefully checked.

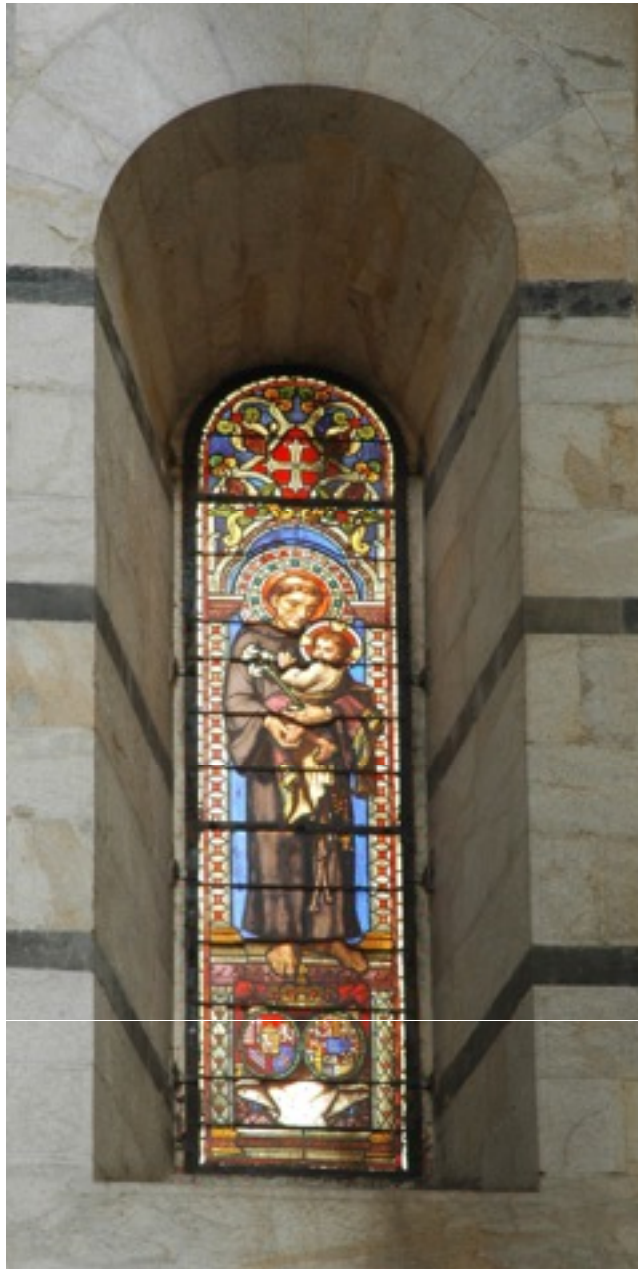
REF.: 14pt in plan of windows

Very little damage, State of repair of leading and grisaille to be carefully evaluated.
